**NSWCCD-65-TR-2005/04** March 2005

## **Preliminary Report on the SIDER Testing of Large-Scale Sandwich Panels**

Subj: SIDER INSPECTIONS OF LARGE-SCALE BALSA CORE PANELS

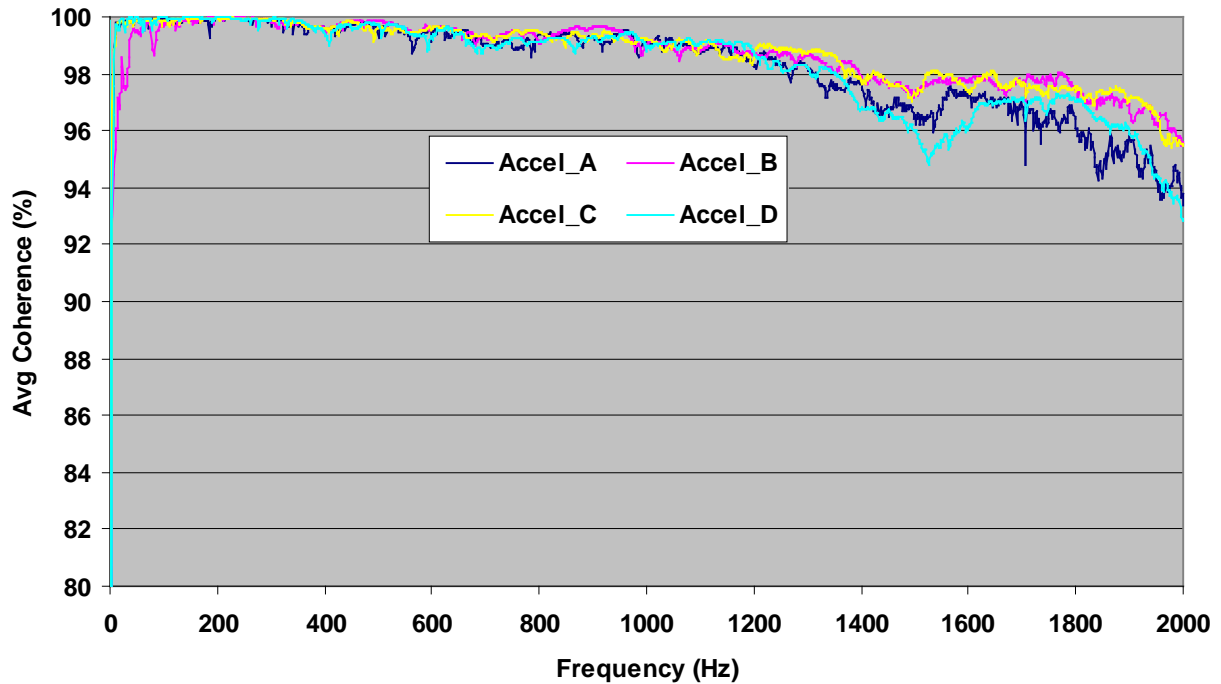
**Figure 4. Average Coherence Comparison – Test Part #2 by Accelerometer**

Part #2 has a slightly lower average coherence. This is consistent with the visual observation that Part #2 looked like it had more manufacturing problems. This corresponds to the panel that had noticeable debonding of the face sheets from the balsa, and the swelling of the balsa.

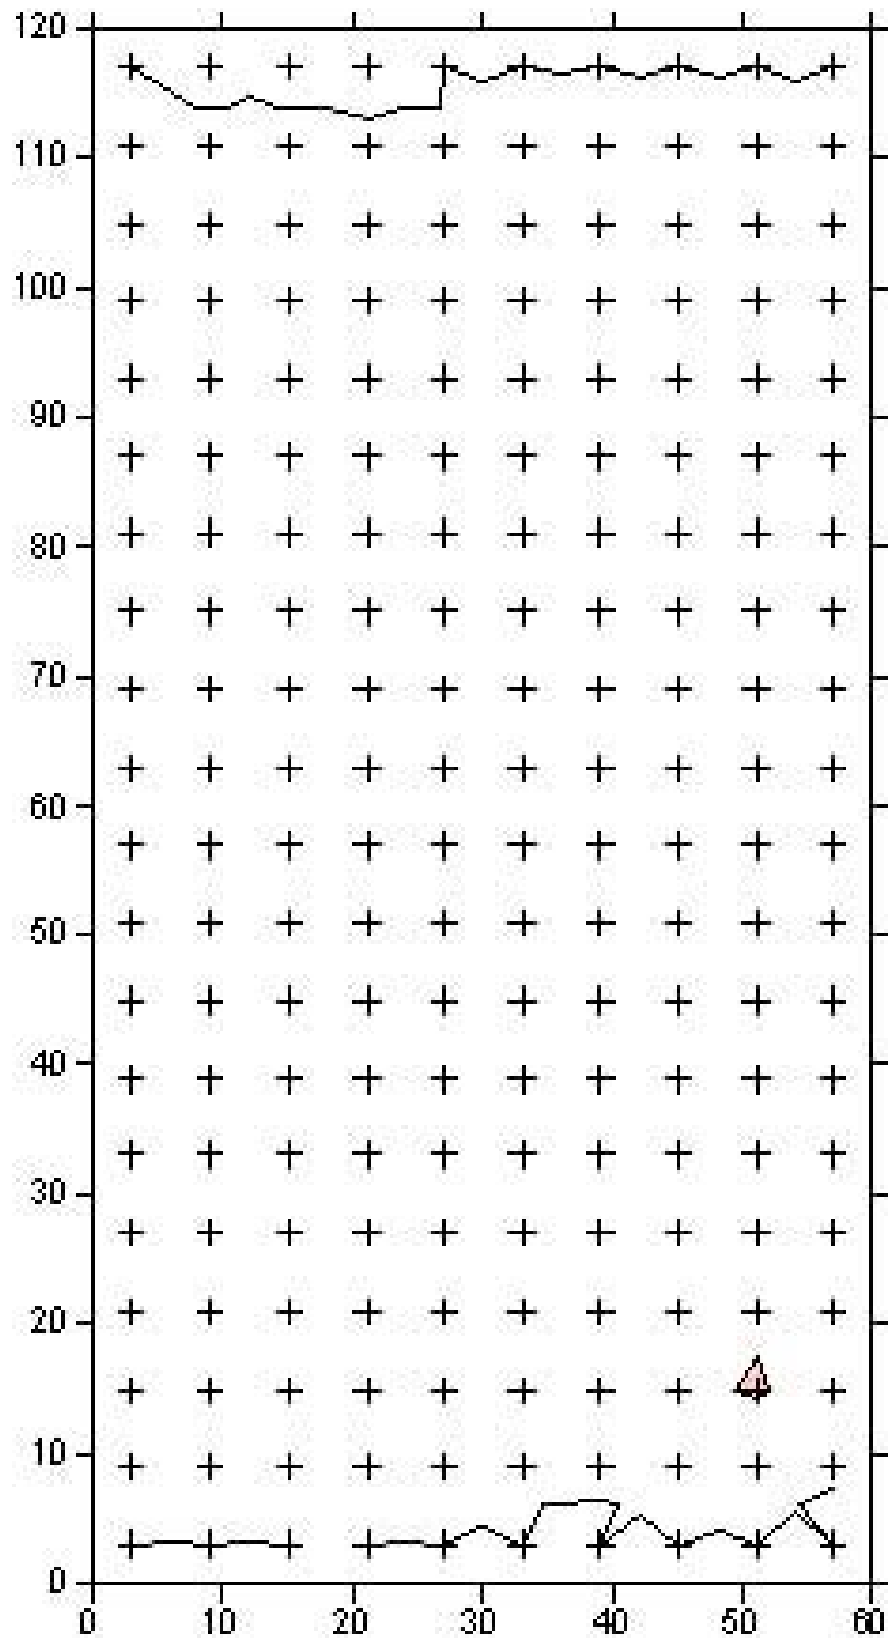
Figure 11. Part #1, Y-Direction Analysis with 10x Magnification

In this case, there are two small areas on panel 1 which show a difference from the rest of the panel. These areas are located near grid points 76 and 86, and grid points 192 and 193. For panel 2, there are many additional areas of concern which are too numerous to mention specifically here. It should be noted that with additional SIDER testing of more components, a baseline SIDER value could be established whereby only indications above this value are considered significant and indicative of manufacturing problems or damage.

Panel #1 showed minimal damage in two distinct areas of the panel. The rest of the panel appears damage free.

*The recommendation is to interrogate those locations only with an alternative technique such as ultrasonics. With additional alternate testing, it may be possible to identify the specific cause of the SIDER features, and whether they are of structural significance.*

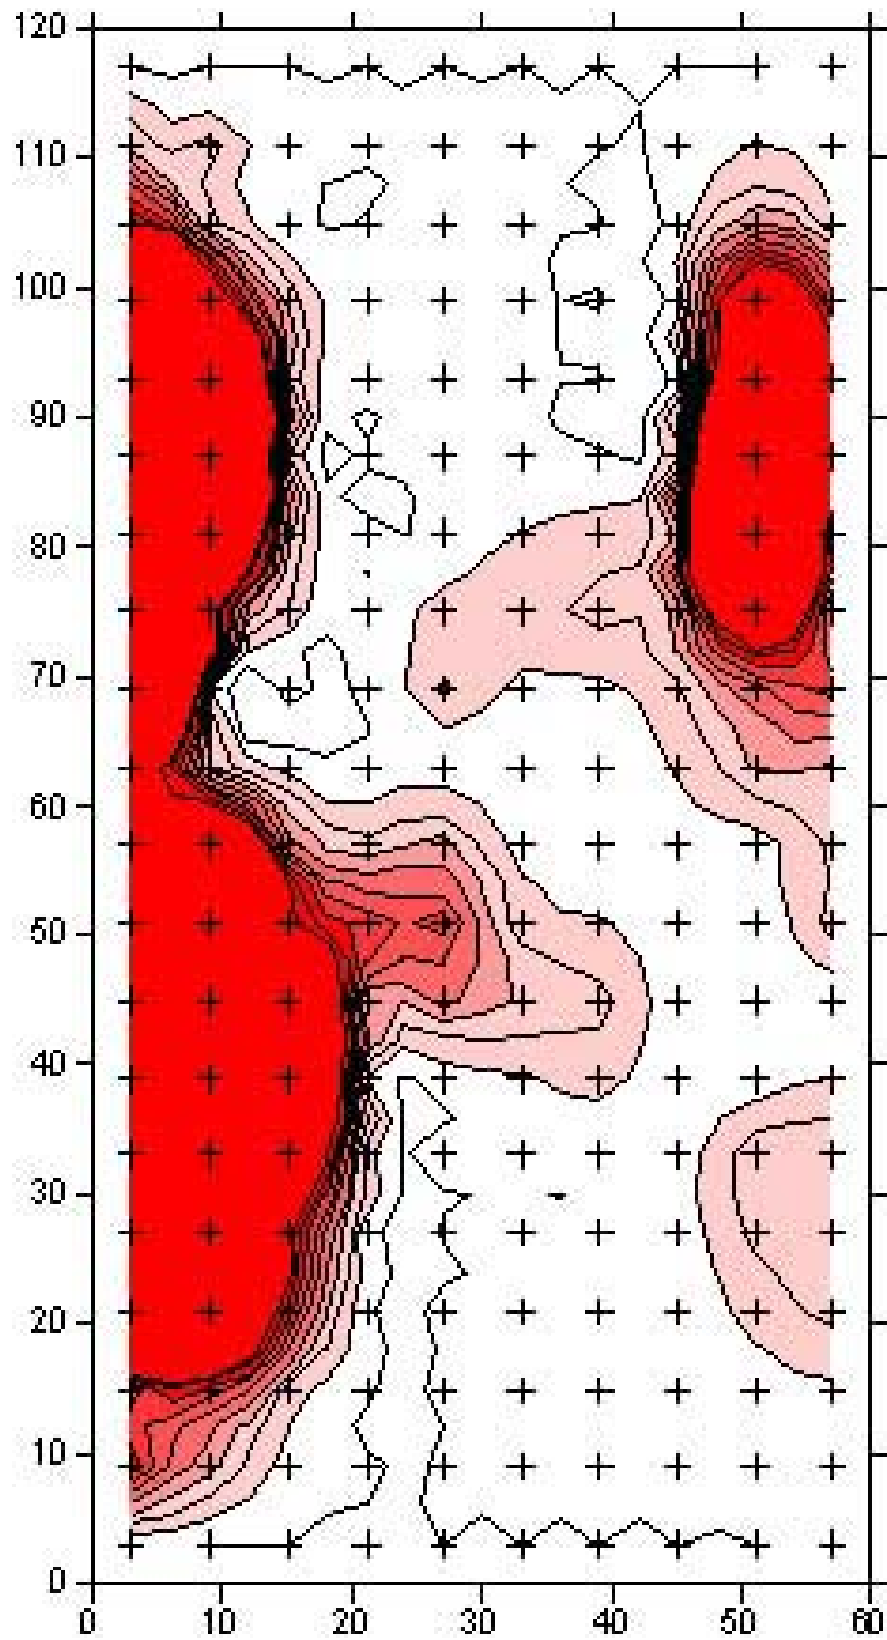
Figure 13. Part #2, Y-Direction Analysis with 10x Magnification

Due to the severe nature of the damage identified in Part #2, it was decided to replot the SIDER results using a different scale. In a single SIDER inspection, when a component demonstrates a feature which significantly dominates the plots, the original auto-scale plots can hide other less severe features that may still be of interest. Rescaling will often enable these less severe features to be identified. If multiple parts were to be inspected, a scaling could be established which would automatically indicate regions above the component norm. Figure 11 through Figure 14 repeat Figure 5 through Figure 8, but with a tenfold magnification. On these plots anything over an original value of 10% is set to a uniform maximum value.

Panel #2 had several large areas of significant damage. These areas cover virtually the entire plate.

*The main recommendation is to use ultrasonics to map out the boundaries of the major delaminations/debonds in order that they can be compared with the SIDER results. Additionally, if time permits, it may be appropriate to test the "SIDER-good" areas to ensure that they are, indeed, damage free.*
